THERMAROOF

Advanced Diagnostic Assessment

***123 Victoria Park Ave,
Toronto, Ontario***

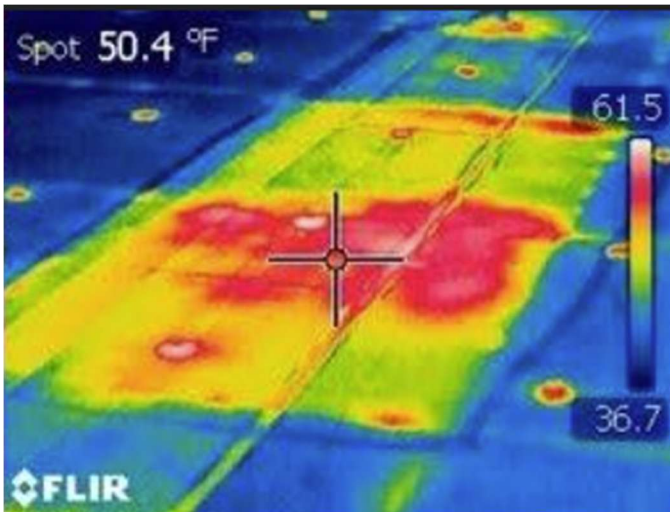
Finding #1: Significant Subsurface Moisture Detected - Severity: **Critical**

The thermal scan reveals a significant temperature differential, consistent with trapped subsurface moisture. This saturated area is actively degrading the insulation's R-value and poses a critical risk for leaks into the building interior if left unaddressed.

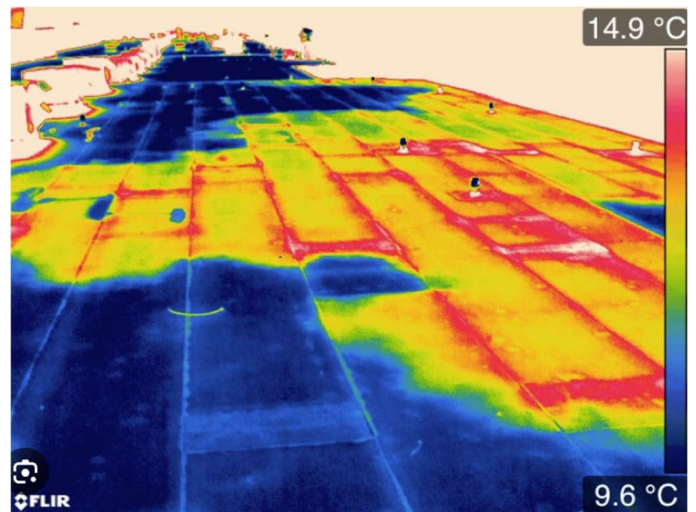
Finding #2: Potential Seam & Fastener Anomalies - Severity: **Critical**

This wider thermal view reveals linear patterns of temperature variation along the roof's seams. This can indicate failing adhesive or seam welds, creating potential entry points for moisture across the roof.

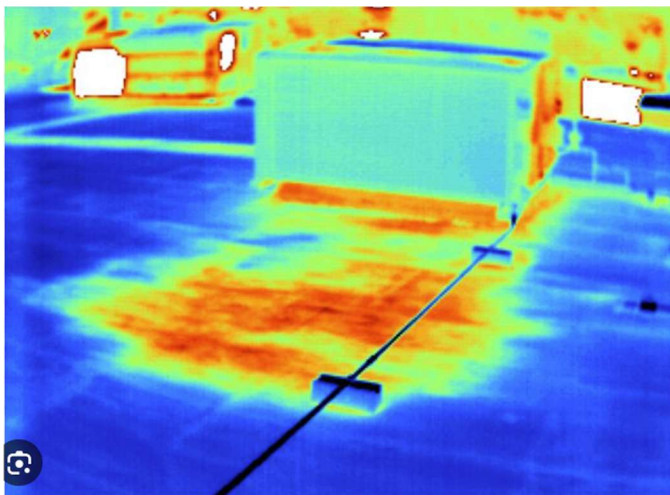
Finding #3: Failed membrane seam - Severity: **Medium**

A faulty seam in the membrane around the base of the curb has allowed condensation from the HVAC unit to penetrate the roof assembly.

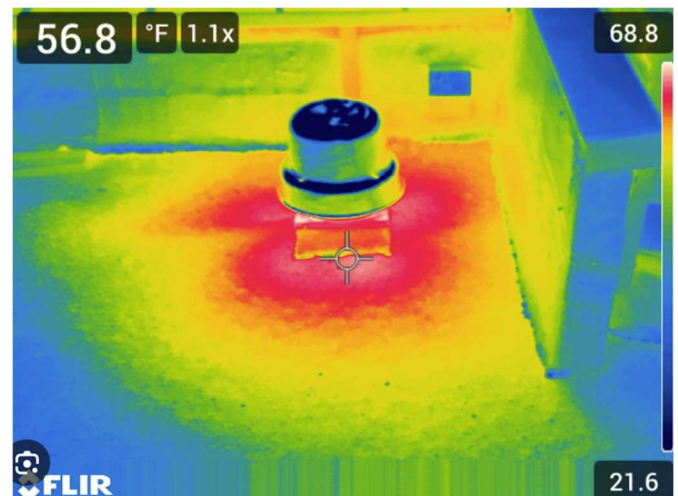
Finding #4: Thermal Anomaly at Roof Vent - Severity: **Medium**

A significant temperature differential is noted around the base of this roof vent, indicating a potential failure in the flashing seal. This type of breach is a common point of failure and allows for both direct water ingress into the roof system and localized energy loss.
